PROPERTY INSPECTION REPORT

2134 W Wilden Ave
Goshen, IN 46528
Inspection Prepared For: Rob Smead
Agent: Jennea Schirr - McKinnies Realty Elkhart

Date of Inspection: 9/16/2024
Year Built: 1986 Size: 6800
Weather: Sunny, 65 to 75 degrees
Kevin Barnes #HI01500046
Aardvark Home Inspectors, Inc.

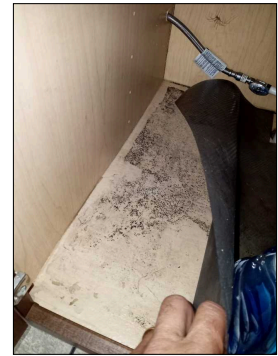
Staining consistent with mold to the cabinet under the kitchen sink

- There is some staining consistent with mold to the cabinet under the kitchen sink; recommend a mold remediation professional fully evaluate this staining consistent with mold and make any recommendations, repairs or replacements deemed necessary

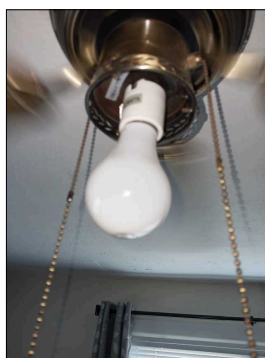
The ceiling fans are missing protective covers at the light fixtures

- Although the ceiling fans operated, the ceiling fans are missing protective covers at the light fixtures; recommend installing protective covers

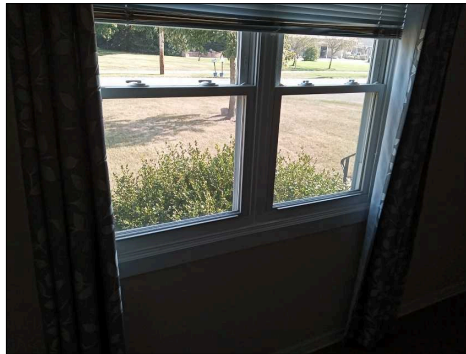
None of the bedroom windows qualify as egress windows according to current guidelines

- The windows operated
- None of the bedroom windows qualify as egress windows according to current guidelines. An egress window must be no more than 44 inches off the floor, must have a minimum window opening of 20 inches wide, must have a minimum window opening of 24 inches high and must have a minimum window opening of 5.7 square feet. It is recommended a window professional fully evaluate the bedroom windows and make any recommendations, repairs or replacements deemed necessary

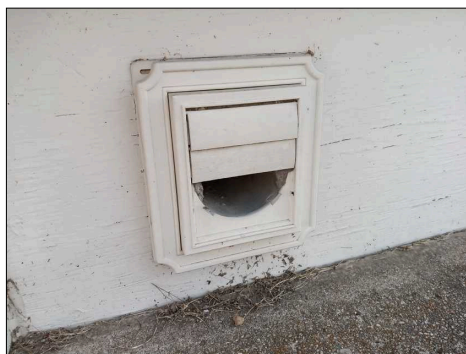
Missing dryer vent louver

- The dryer vent cover is missing a louver; mice may enter the structure here. Recommend replacement of the vent cover

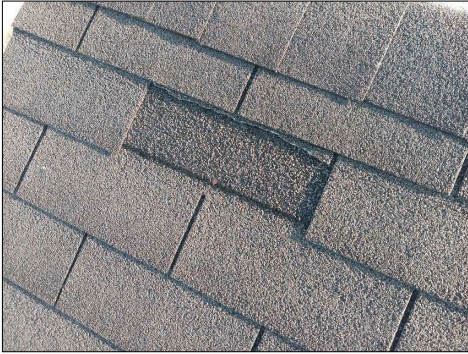
Broken/missing shingle tab

- There is a broken/missing shingle tab on the roof and there is a gap where the chimney meets the roof; It is recommended a licensed roofing professional make these repairs and fully evaluate the roof and make any recommendations, repairs or replacements deemed necessary

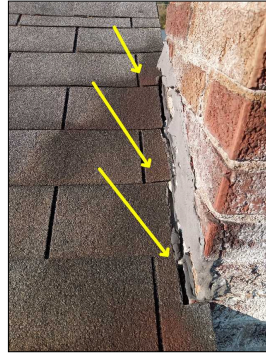
Gap where the chimney meets the roof

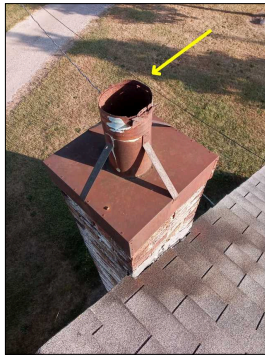
Missing metal screened flue pipe cover

- There is some loose/cracking or missing mortar between some chimney bricks and the chimney is missing a metal screened flue pipe cover to prevent birds or rodents from nesting in the chimney; recommend repair by a qualified contractor or the chimney could be removed since it is no longer in use

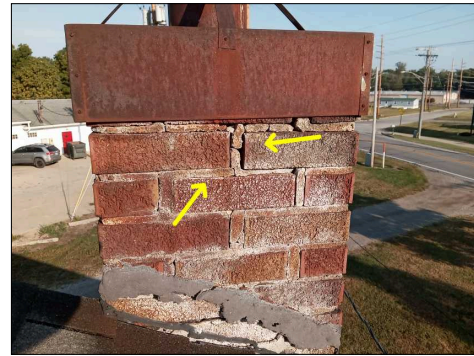
Loose/cracking or missing mortar between some chimney bricks

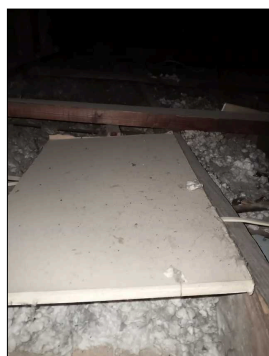
The access panel is not insulated

- The access panel is not insulated; recommend fully insulating the access panel to prevent heat loss

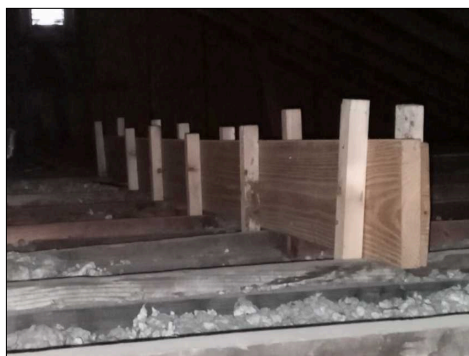
Load bearing wall support header is missing joist hangars

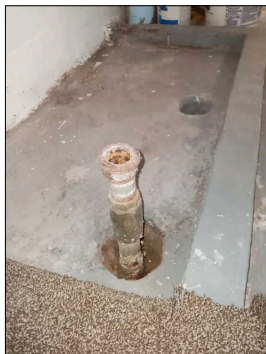
Old shallow well pipe should be capped

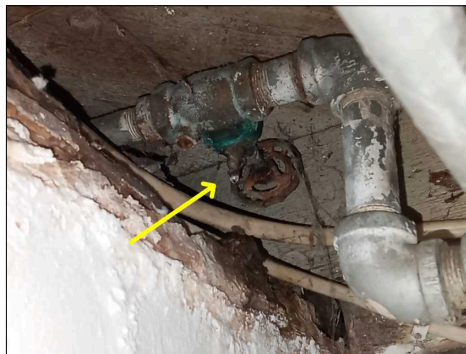
There is an active drip/leak in the plumbing visible from the basement

- There are a couple active drips/leaks in the plumbing visible from the basement; recommend repair by a qualified contractor (replacement of these old galvanized supply pipes is highly recommended to prevent future leaks)

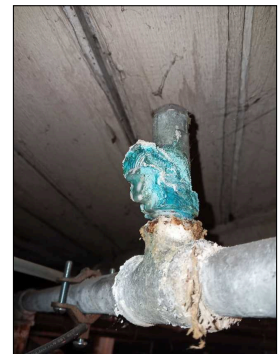
There is an active drip/leak in the plumbing visible from the basement

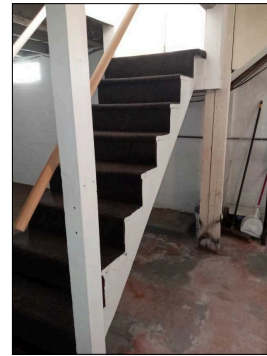
Missing banister railings with spindles spaced no more than 4 inches apart

- The basement stairway is missing banister railings with spindles spaced no more than 4 inches apart to prevent someone from stepping off the side of the stairway; recommend installing banister railings with spindles

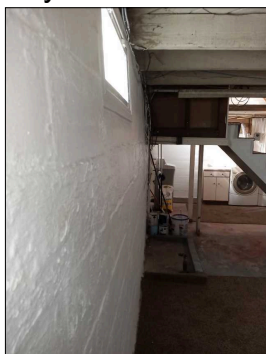
Bowing to the foundation

- The foundation is an older hollow block foundation which has some signs of moisture staining, staining consistent with mold, scaling and bowing. It is possible during heavy periods of rain that water could leak through the foundation. Signs of past water penetration were found at time of the inspection.
- If water does leak into the basement then it is recommended a foundation or water proofing expert fully evaluate the foundation and make any recommendations, repairs or replacements deemed necessary

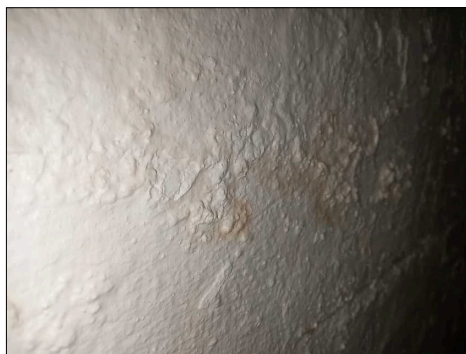
There is some moisture staining and scaling to the foundation visible from the basement

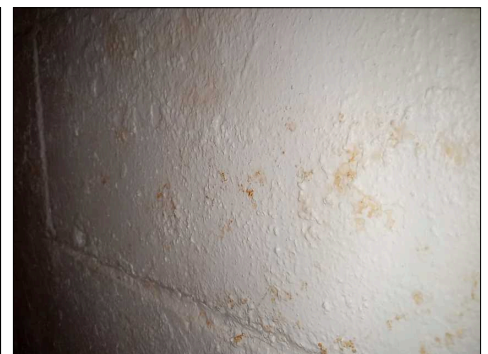
There is some moisture staining and scaling to the foundation visible from the basement

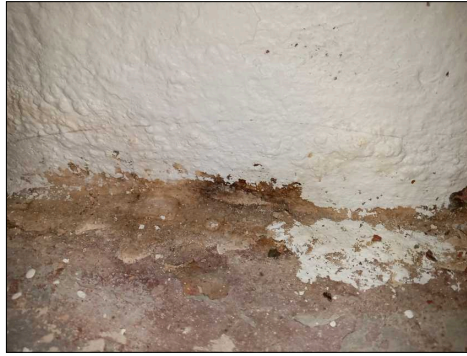
There is some staining consistent with mold to the foundation visible from the basement

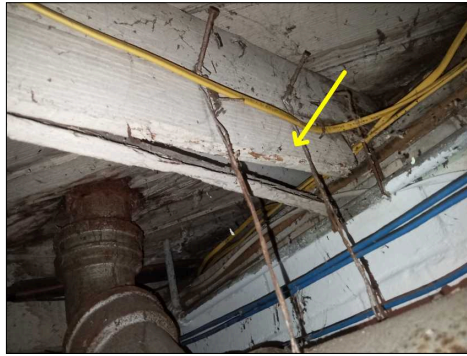
There is a cracked joist visible from the basement that should be repaired

- There is a cracked joist visible from the basement; recommend repair by a qualified contractor

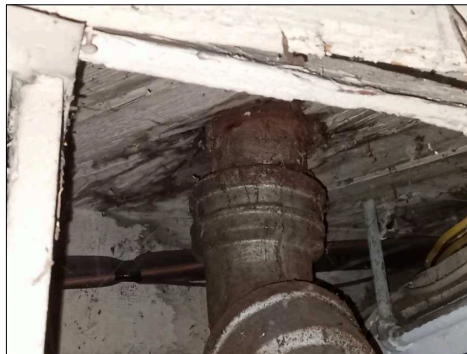
- There is some moisture staining to the floor decking visible from the basement most likely caused by plumbing leaks in the past; these areas were dry during the inspection

There is some moisture staining to the floor decking visible from the basement

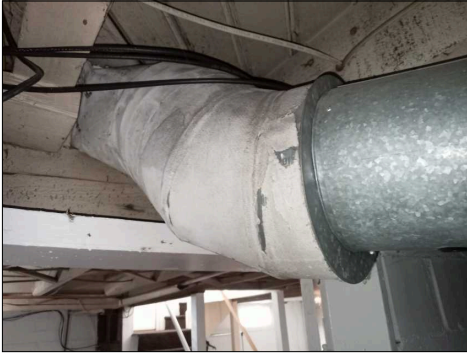
Fibertape on duct lines

- Although air flow was detected coming from all of the ducts, the bathroom duct is missing a vent cover
- The heating ductwork has fibrous material present that may or may not contain asbestos. The EPA recommends leaving it undisturbed if in good condition or encapsulation with insulation, latex paint, etc. For further information, visit the EPA website and/or contact a qualified asbestos abatement professional.

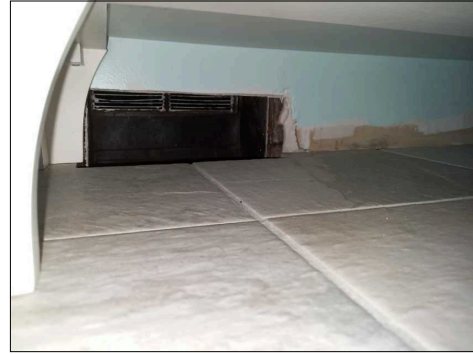
A missing vent cover in the bathroom

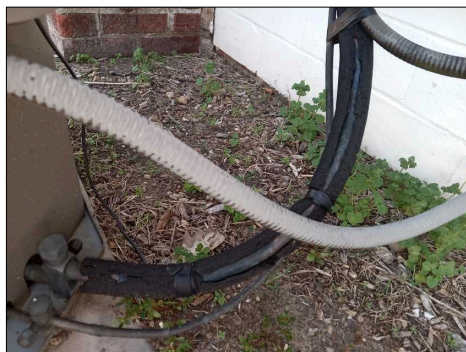
Deteriorated insulation on the a/c lines

- Deteriorating insulation near the A/C condenser unit. Recommend repairs to improve efficiency.

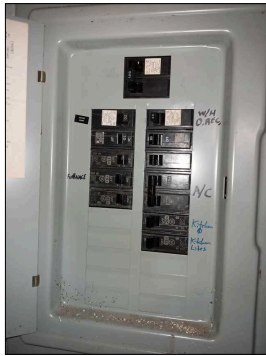
The electrical panel is not properly or completely labeled

- The electrical panel is not properly or completely labeled; recommend fully labeling the electrical panel and all sub panels
- There is a missing knock out hole cover in a sub panel in the basement and there is extensive rusting in a sub panel; recommend repair or replacement by a qualified contractor

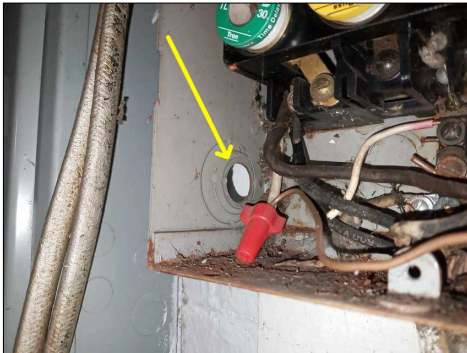
A missing knock out hole cover in a sub panel in the basement

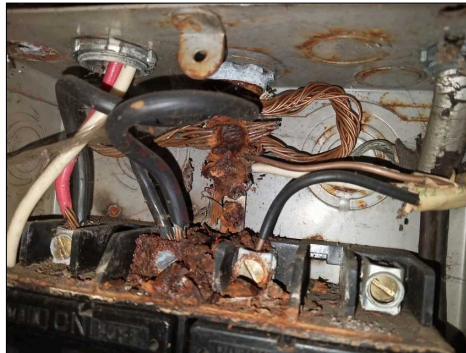
Extensive rusting and corrosion in a sub panel in the basement

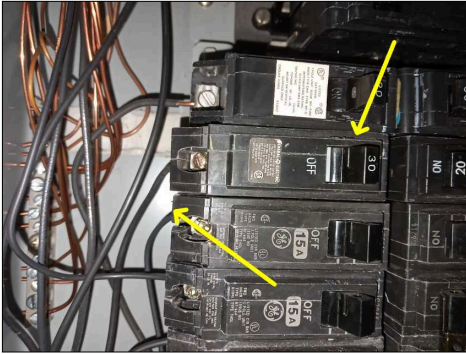
There is a 12 gauge wire on a 30 amp breaker in the electrical panel

- There is a double posted breaker in the electrical panel and there is a 12 gauge wire on a 30 amp breaker in the electrical panel (12 gauge wires are rated for 20 amp maximum) recommend repair or replacement by a qualified contractor

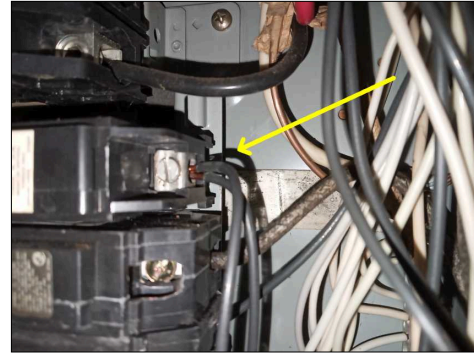
There is a double posted breaker in the electrical panel

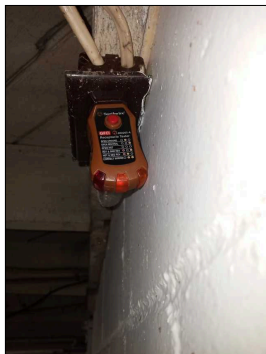
Some outlets throughout the house tested as open ground

- Some outlets throughout the house are older 2 prong type outlets which may indicate that there is some older knob and tube type wiring that is still active and some outlets throughout the house tested as open ground; recommend repair or replacement by a qualified contractor

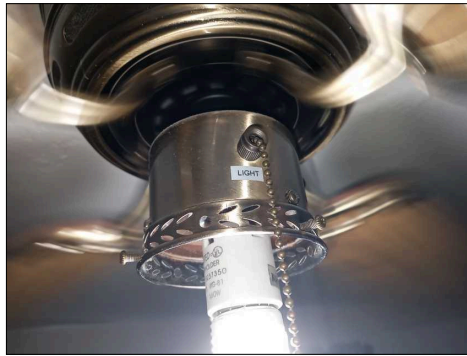
The bedroom number 1 ceiling fan pull chain switch is inoperable

- The bedroom number 1 ceiling fan pull chain switch is inoperable; recommend repair or replacement by a qualified contractor

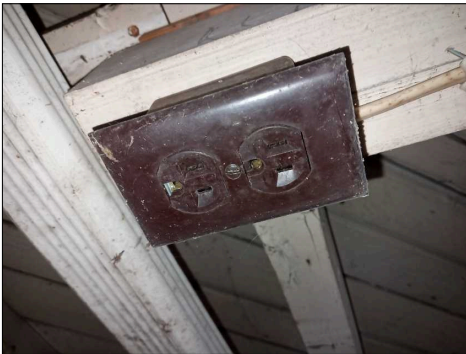
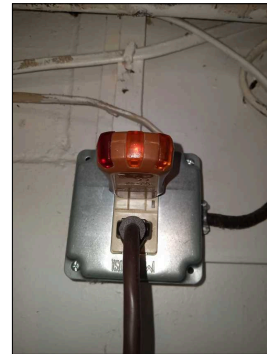
The basement outlets are not all GFCI protected A basement GFCI protected outlet tested as open ground

- A basement GFCI protected outlet tested as open ground; recommend labeling this outlet "no equipment ground"
- The basement outlets are not all GFCI protected; recommend replacement by a qualified contractor

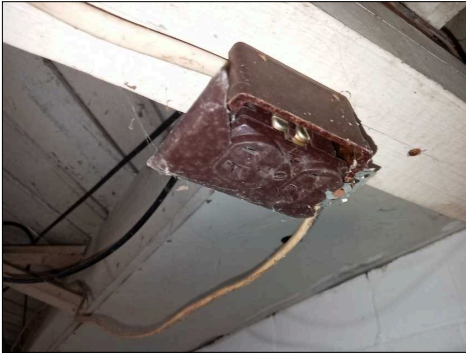
A basement outlet has a damaged cover plate

- A basement junction box is missing a cover plate and an outlet has a damaged cover plate; recommend installing cover plates

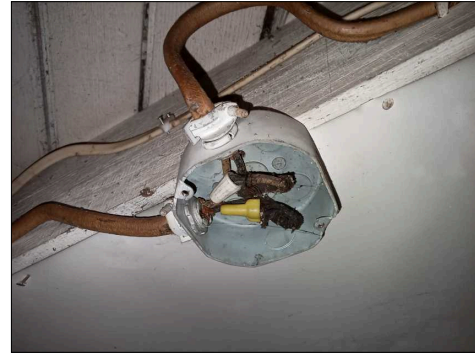
A basement junction box is missing a cover plate

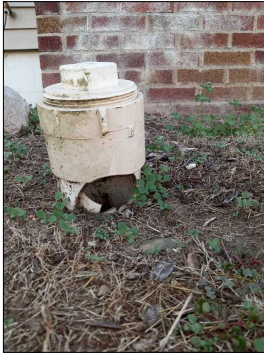
The north sewer clean out is damaged

- The cast iron sewer drain pipe in the basement is cracked and the north exterior sewer clean out is damaged; recommend repair or replacement by a qualified contractor

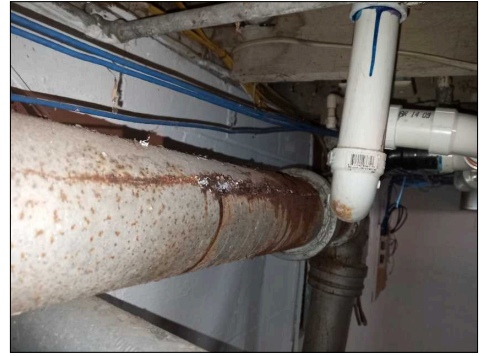
The cast iron sewer drain pipe is cracked

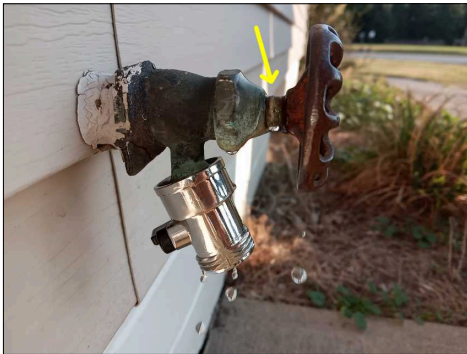
The south exterior hose bib leaks at the handle

- The south exterior hose bib leaks at the handle and the north exterior hose bib leaks at the handle; recommend replacement by a qualified contractor

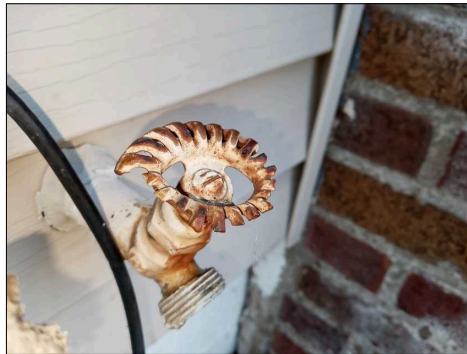
The north exterior hose bib has a damaged handle

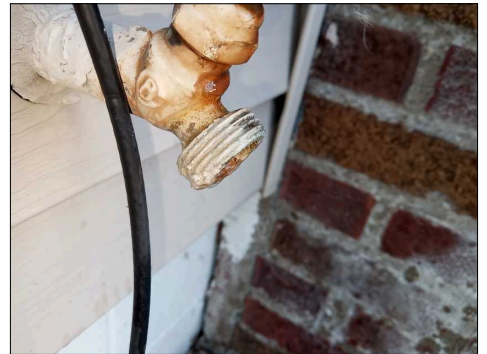
The north exterior hose bib has corroded hose threads

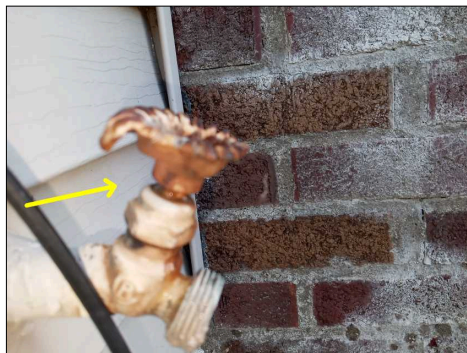
The north exterior hose bib leaks at the handle

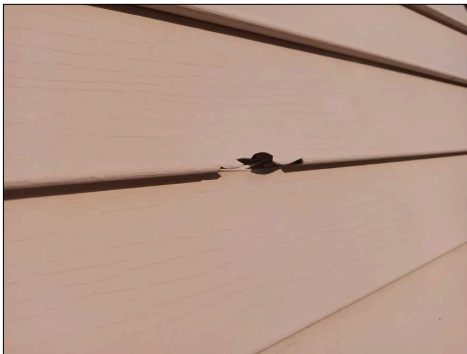
Holes in the exterior siding

- Common siding defects or other cosmetic damage is typical wear and not usually a cause for concern; repair or replace damaged sections as needed.
- There is a gap where the chimney meets the exterior siding that should be sealed; recommend a weather resistant sealant

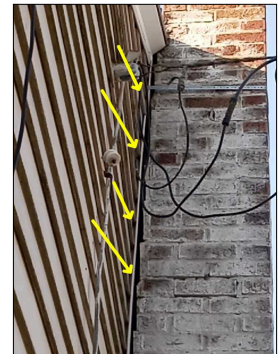
Gap where the chimney meets the exterior siding

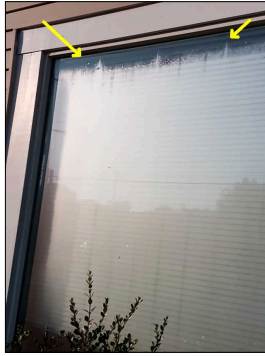
Moisture staining between the glass panes

- There is some moisture staining between the glass panes of the living room east window implying blown seals; recommend repair or replacement by a qualified contractor

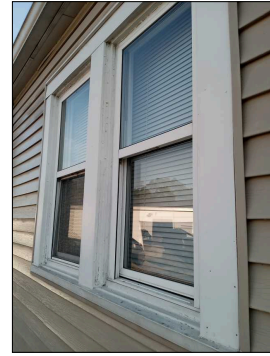
A window is missing a screen

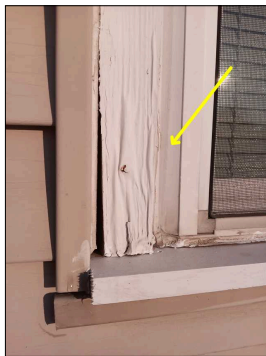
Peeling paint and wood deterioration to the exterior window frames and trim

- There is some peeling paint and wood deterioration to the exterior window and door frames and trim; recommend repair, scraping, priming and painting

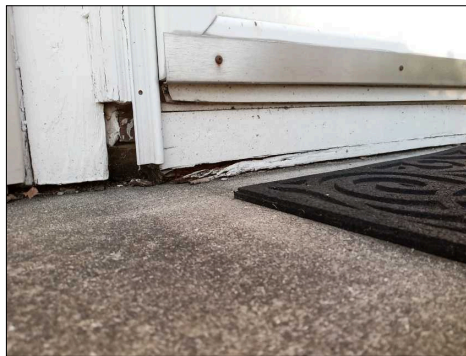
Peeling paint and wood deterioration to the exterior door frames and trim

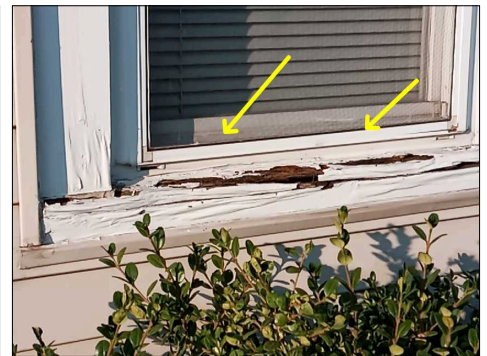
Peeling paint and wood deterioration to the exterior window frames and trim

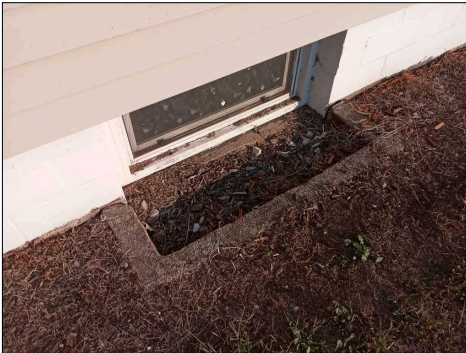
The basement window wells may need window well covers installed

- The drainage around the house is not satisfactory because a downspout is missing an extension and the ground around the foundation has a flat to negative slope which is typically found in this region and it is recommended ongoing maintenance be performed to divert water away from the foundation.
- The basement window wells may need window well covers installed to divert water away from the foundation

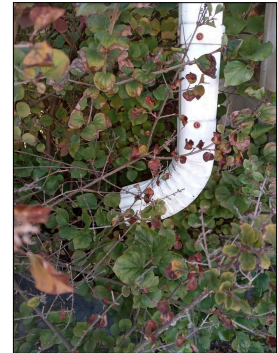
A downspout is missing an extension

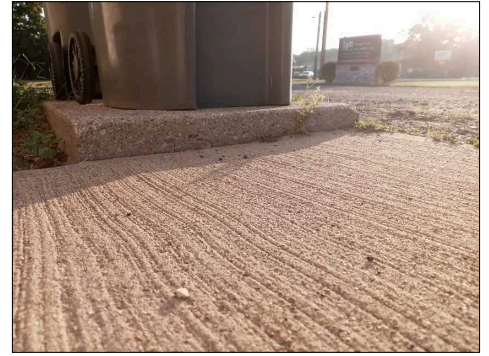
Unevenness to the sidewalk concrete possibly posing a trip hazard

- The sidewalk at the south exterior entry has settled or heaved up creating a tripping hazard; recommend repairs or use caution when near.
